# Manhole Inspection Summary

Manhole # S65A\_\_011MH

**Location** Address: **6301 Lombard St.**

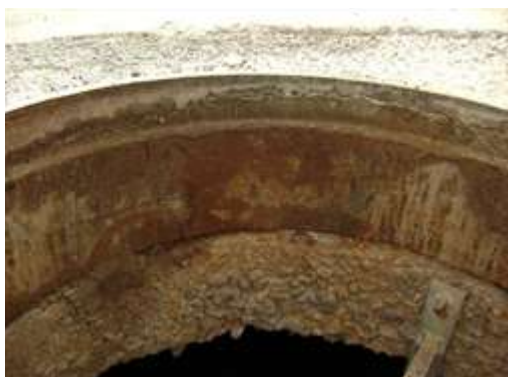
Defect 1

Infiltration: ☐ None ☒ **Joint** ☐ Cracks ☐ Mortar ☐ Roots ☐ Wall

Infiltration

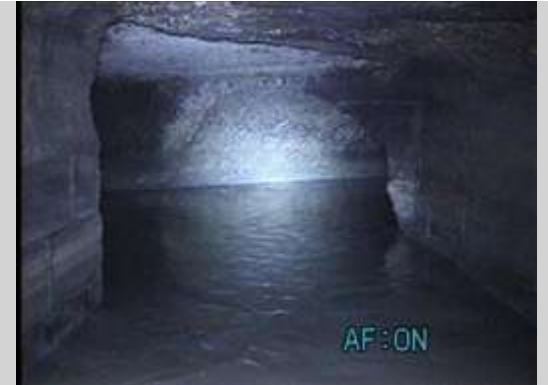
12 O'Clock Outflow

60.0 in. (w) x 60 in. (h) Square Gravity Sewer  
Pipe Out @ 12 O'Clock

Pipe Height: **57.6** (in.) Rod and Bar (Angled)  
Pipe Material: **Unknown** ☐ Pipe Lined  
Invert Depth: **15.50** (ft.) Flow Characteristics: **Fast**  
Deposits: ☒ None ☐ Mud ☐ Sludge ☐ Debris ☐ Grease  
Silt Depth: (in.) Deposits Extent:  
Infiltration: **None** Pipe Seal Cond: **Sound**

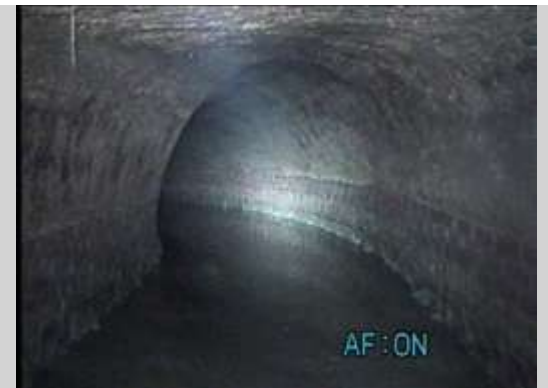
6 O'Clock Inflow

60.0 in. (w) x 60 in. (h) U-shape with flat top Gravity Sewer  
Pipe In @ 6 O'Clock

Pipe Height: **57.6** (in.) Rod and Bar (Angled)  
Pipe Material: **Unknown** ☐ Pipe Lined  
Invert Depth: **15.25** (ft.) Flow Characteristics: **Fast**  
Deposits: ☒ None ☐ Mud ☐ Sludge ☐ Debris ☐ Grease  
Silt Depth: (in.) Deposits Extent:  
Infiltration: **None** Pipe Seal Cond: **Sound**
